Short Investigation Bulletin

DATE: 28th June 2021
REPORT # AO21-20
AIRCRAFT REGISTRATION: C-130 #379
INVESTIGATION STATUS: Completed

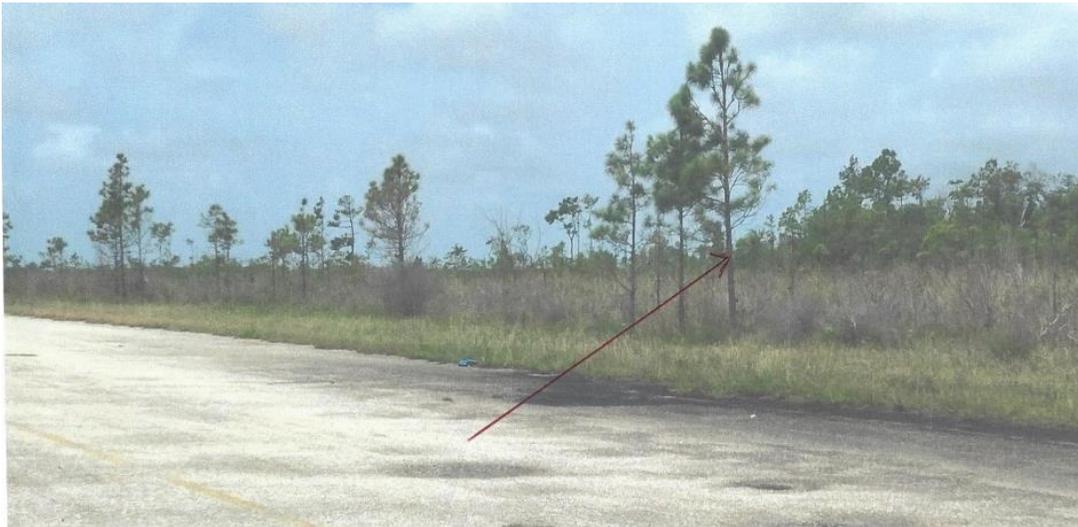
Reports received indicate that while maneuvering along the taxiway, the aircraft's right wing came into contact with a pine tree that resulted in damages to the right wing flaps. There were no injuries to the six (6) crewmembers on board.

Photo of pine trees on the edge of the taxiway at the Andros Town Int'l Airport, Andros, Bahamas

One (1) urgent safety recommendation was issued to the Airport Authority, Family Island Airport Division (FIAD), (operator of the airport), to take the necessary mitigating steps to address the issue of removal of pine trees within the vicinity of the taxiway that present a hazard to aircraft using the taxiway.
