AIRCRAFT ACCIDENT REPORT

POWERPLANT FAILURE

CESSNA CARAVAN CE208B,
N954PA

**AAIPU# A08-26107
Adopted APRIL 6, 2010**

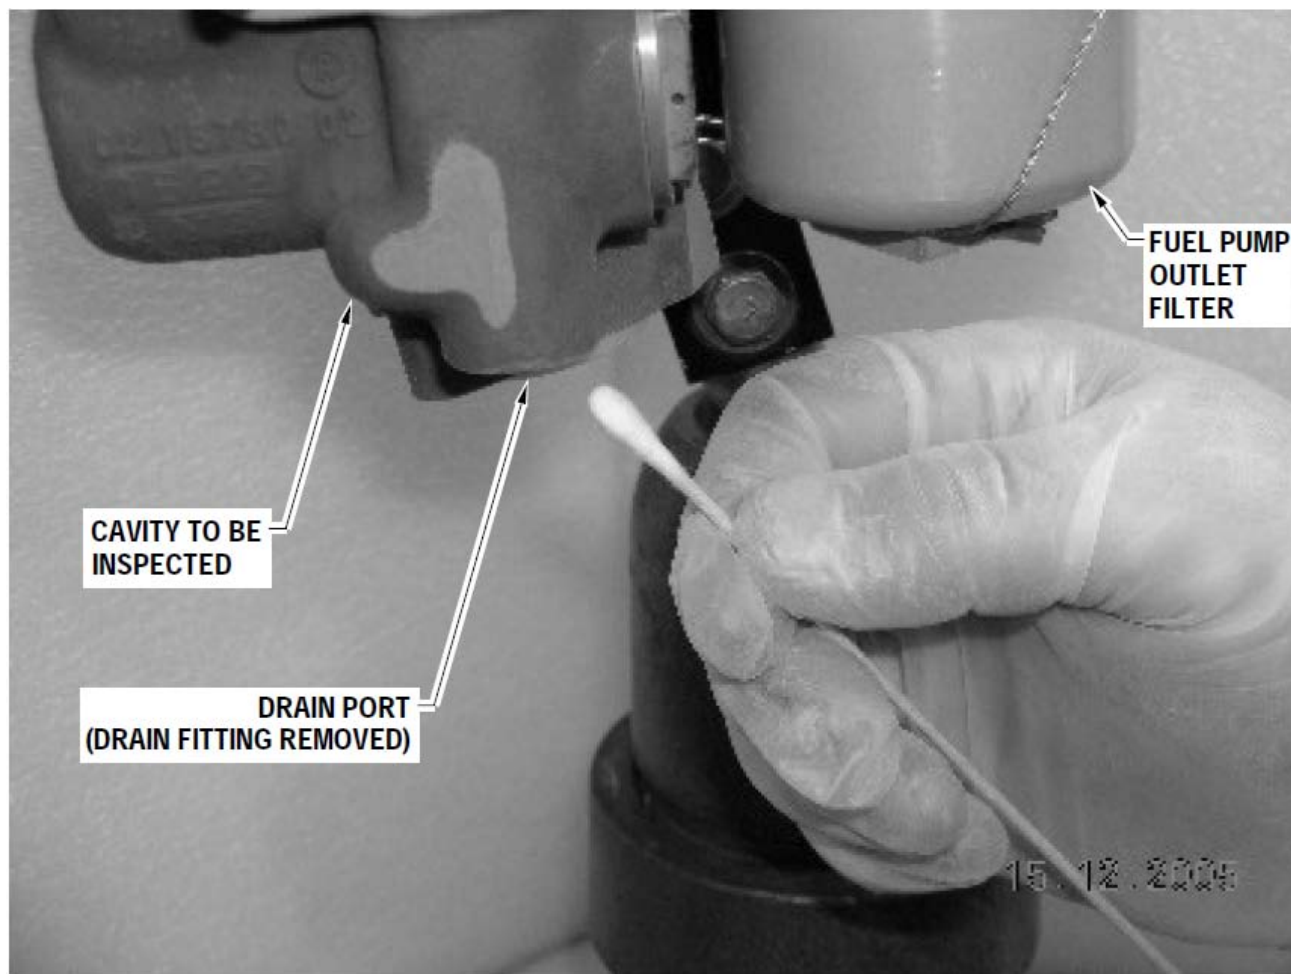
Fuel Pump In-situ Inspection
Figure 203

- (2) Insert a cotton swab, or equivalent, 1.0 to 1.5 in. deep into the drain port of the fuel pump (Ref. Fig. 203).
- (3) Angle the cotton swab (Ref. Fig. 203) and roll it inside the drain port to collect evidence of a possible reddish-brown deposit (iron oxide).
- (4) If no reddish-brown (iron oxide) stain is evident, the fuel pump may remain in service.

- (5) If a reddish-brown (iron oxide) stain is evident:
- (a) Remove fuel pump (Ref. Para. 6.).
 - (b) Examine the input coupling shaft area of the pump face (Ref. Fig. 201) for residue from fretting corrosion (iron oxide deposit). If none is present, the pump may remain in service.
 - (c) Evidence of corrosion residue indicates possible spline wear. Return the fuel pump to an approved overhaul facility.
 - (d) Install a replacement fuel pump (Ref. Para. 6.).
