AIRCRAFT ACCIDENT REPORT

LOSS OF CONTROL INFLIGHT AND IMPACT WITH TERRAIN

CESSNA 421B

N421MM

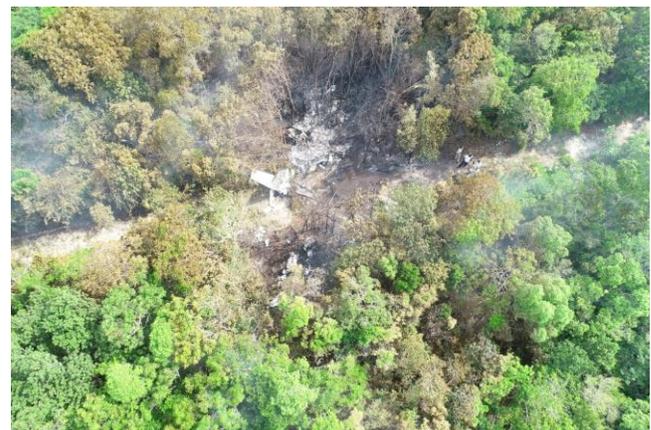
Figure 2. Aerial shot of crash site

As the aircraft crashed off-field, in a heavily wooded area not serviced by easily accessible roads, first responders and rescue personnel encountered difficulty in locating the wreckage at first.

The aircraft was finally found off a dirt road paralleling runway 09/27 approximately 0.41 miles north of the threshold of runway 09.

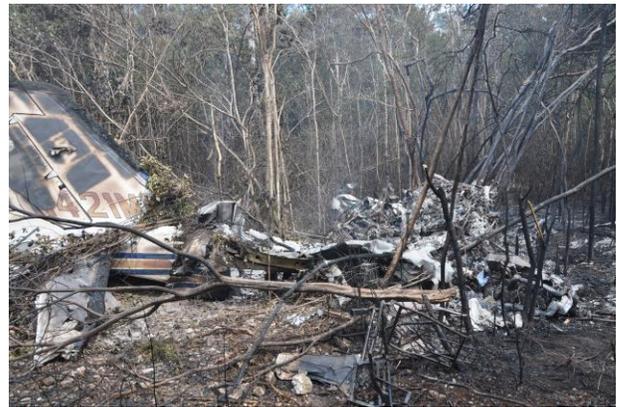
Figure 4. Crash site

The energy path through the trees was measured at 355° magnetic. The aircraft forward of the aft pressure bulkhead was significantly damaged by the post-impact fire. Both wings exhibited impact and fire damage.

The cabin area was destroyed by the post-impact fire. One front seat restraint system buckle and one passenger seat buckle were observed in the latched conditioned.
