Aviation Short Investigation Final Report

Wheels up landing involving

BE-1900, N376SA

I16-000010

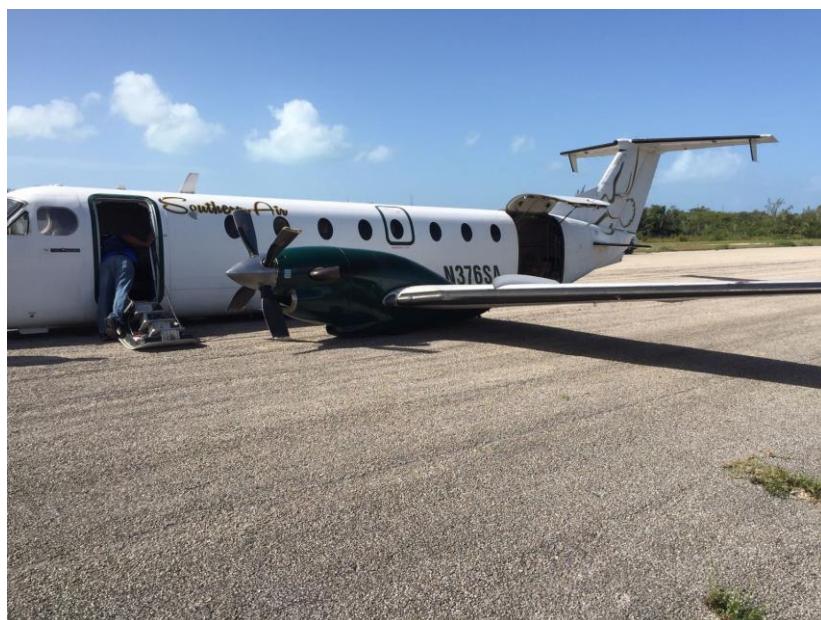
N376SA a BE1900 aircraft with a crew of two, and nine passengers, landed on runway 09 with the gear in the retracted position. The captain reported that 10 miles from landing, when the aircraft flaps were selected to the approach position for landing, at this point he realized that the flaps were not working. He further stated that he elected to continue the approach and prepare for a no-flaps landing. The performance charts for the aircraft were consulted and preparations were made for the landing. Both pilot claimed landing gears were selected to the down and locked position and three green lights confirming gears locked was noted. However, upon touchdown, the gears retracted causing the aircraft to land on its belly. No injuries were reported to occupants of the aircraft
