AVIATION OCCURRENCE BULLETIN

DATE: 24TH MAY 2019
REPORT # AO-19-000016
AIRCRAFT REGISTRATION: C6-TIM
INVESTIGATION STATUS: COMPLETED

| Aircraft details | |
|--|--|
| Aircraft Type and Registration: | Piper PA-23-250, C6-TIM |

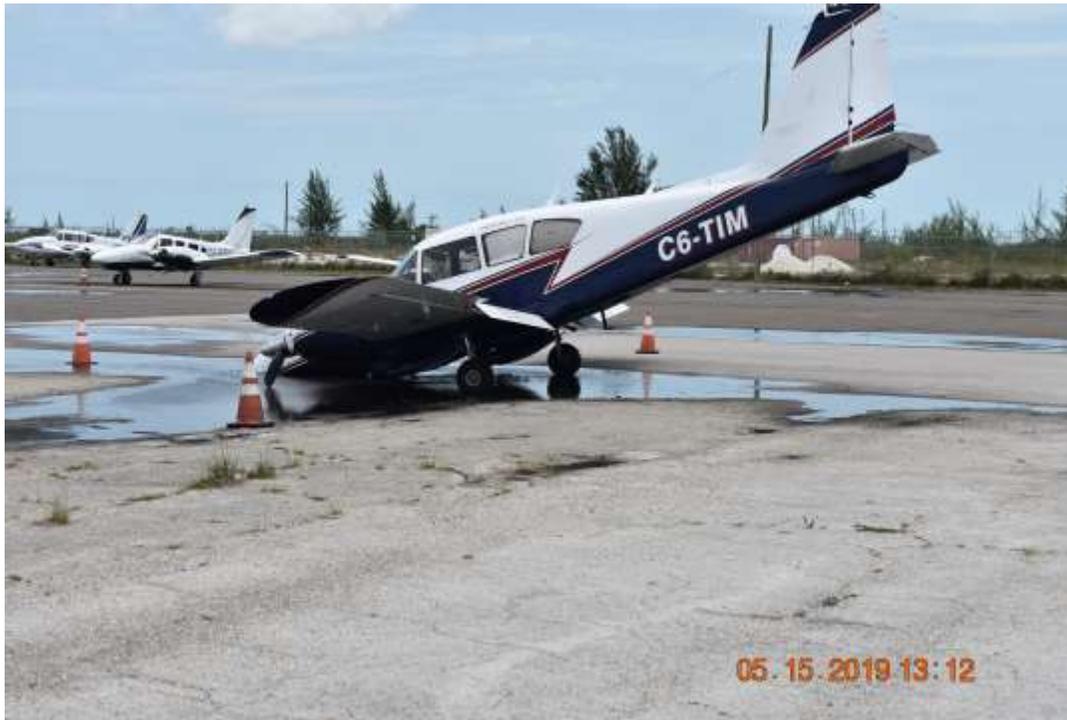
Photo – General Aviation Center (MYNN)

The pilot reported that during his taxi on the ramp at the General Aviation Center, while taxiing to a parking spot, his nose gear fell into a pothole that was obscured due to the standing water in the ramp area. The pot hole contact resulted in the nose gear collapsing causing damage to the nose of the aircraft, both propellers and possibly both engines. No injuries were received by the occupants of the aircraft.

During the course of our investigation, note was taken of various sections of the ramp area at the General Aviation Center where potholes were present that posed a potential threat to manoeuvring aircraft; especially during wet conditions in the aftermath of rain where these potholes are filled with standing water and are unable to be seen (as was the case in this accident).

The AAID recommends that Odyssey Aviation takes measures to address the hazardous condition of the paved surfaces in the ramp area at the General Aviation Center.
