# **AIRCRAFT ACCIDENT REPORT**

**GEAR COLLAPSE AND RUNWAY EXCURSION**

**SAAB 340A**

**C6-HBW**

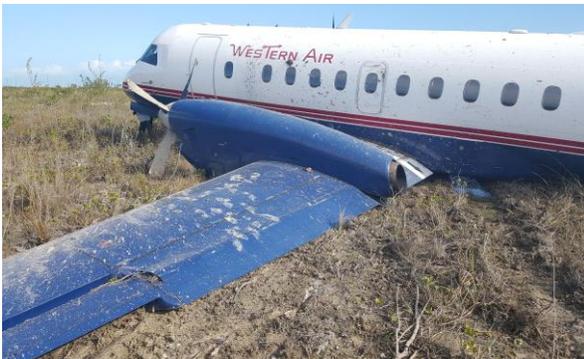
1. This left wing was substantially damaged, as a result of contact with the runway and ground surface during the excursion into the muddy area.

2. Due to contact with the runway, the lower wing panel was damaged. The left wing tip, left aileron and left flap also sustained damages due to

contact with the runway and subsequent ground surface it travelled across during the excursion.

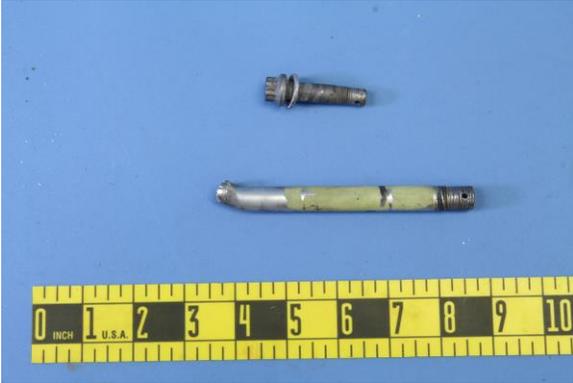
In light of what was previously reported by the crew, it was suspected that landing gear bolt to the LH Main Gear Actuator Bracket P/N IR 134736 may have in and of itself been the cause of the landing gear failure which resulted in a runway excursion.

Results of the metallurgic analysis confirmed “the larger bolt was fractured and the head portion was not received. The fractured displayed bending deformation adjacent to the fracture and fracture features indicative of a bending overstress. No indications of progressive cracking was noted. The threads on the bolt was also partially sheared and sheared nut threads were present. The threads of the smaller bolt was also partially sheared but otherwise

the bolt was complete. Both bolts appeared to be steel alloys.

The bolt analysis was subsequently completed and the results confirmed the bolt was not a contributing factor in the accident.

Prior to the return of the results of the bolt analysis, Western Air embarked on a proactive campaign to inspect all related attachments in the rest of the fleet. No abnormalities were found in the remaining fleet.
