AIRCRAFT ACCIDENT REPORT

LOSS OF CONTROL INFLIGHT AND IMPACT WITH TERRAIN

CESSNA 421B

N421MM

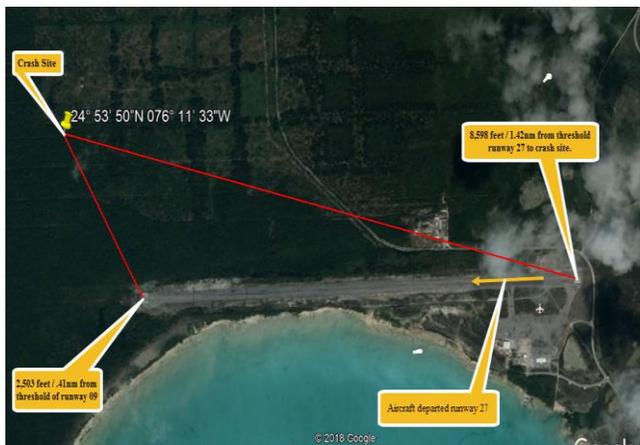
Figure 1. Area map with distances

On 5th June, 2018 at approximately 3:45pm local, (Eastern Daylight Time)¹, a Cessna 421B aircraft crashed in dense bushes shortly after departure from Runway 27 at Rocksound Int'l Airport, Rocksound, Eleuthera, Bahamas. The crash site was located approximately 2,503 feet / .41 nautical mile (nm) north of the threshold of Runway 09 and 8,588 feet / 1.42 nm from threshold of runway 27². The pilot and 2 passengers were killed and the aircraft was destroyed by impact forces and a post-crash fire.

The aircraft was finally found off a dirt road paralleling runway 09/27 approximately 0.41 miles north of the threshold of runway 09.
