# **AIRCRAFT ACCIDENT REPORT**

## **FINAL REPORT Human Factor (Pilot Induced) Error**

**CESSNA 210  
N9690X  
Marsh Harbour, Abaco Bahamas  
May 27<sup>th</sup>, 2004**

**Report A0411710**

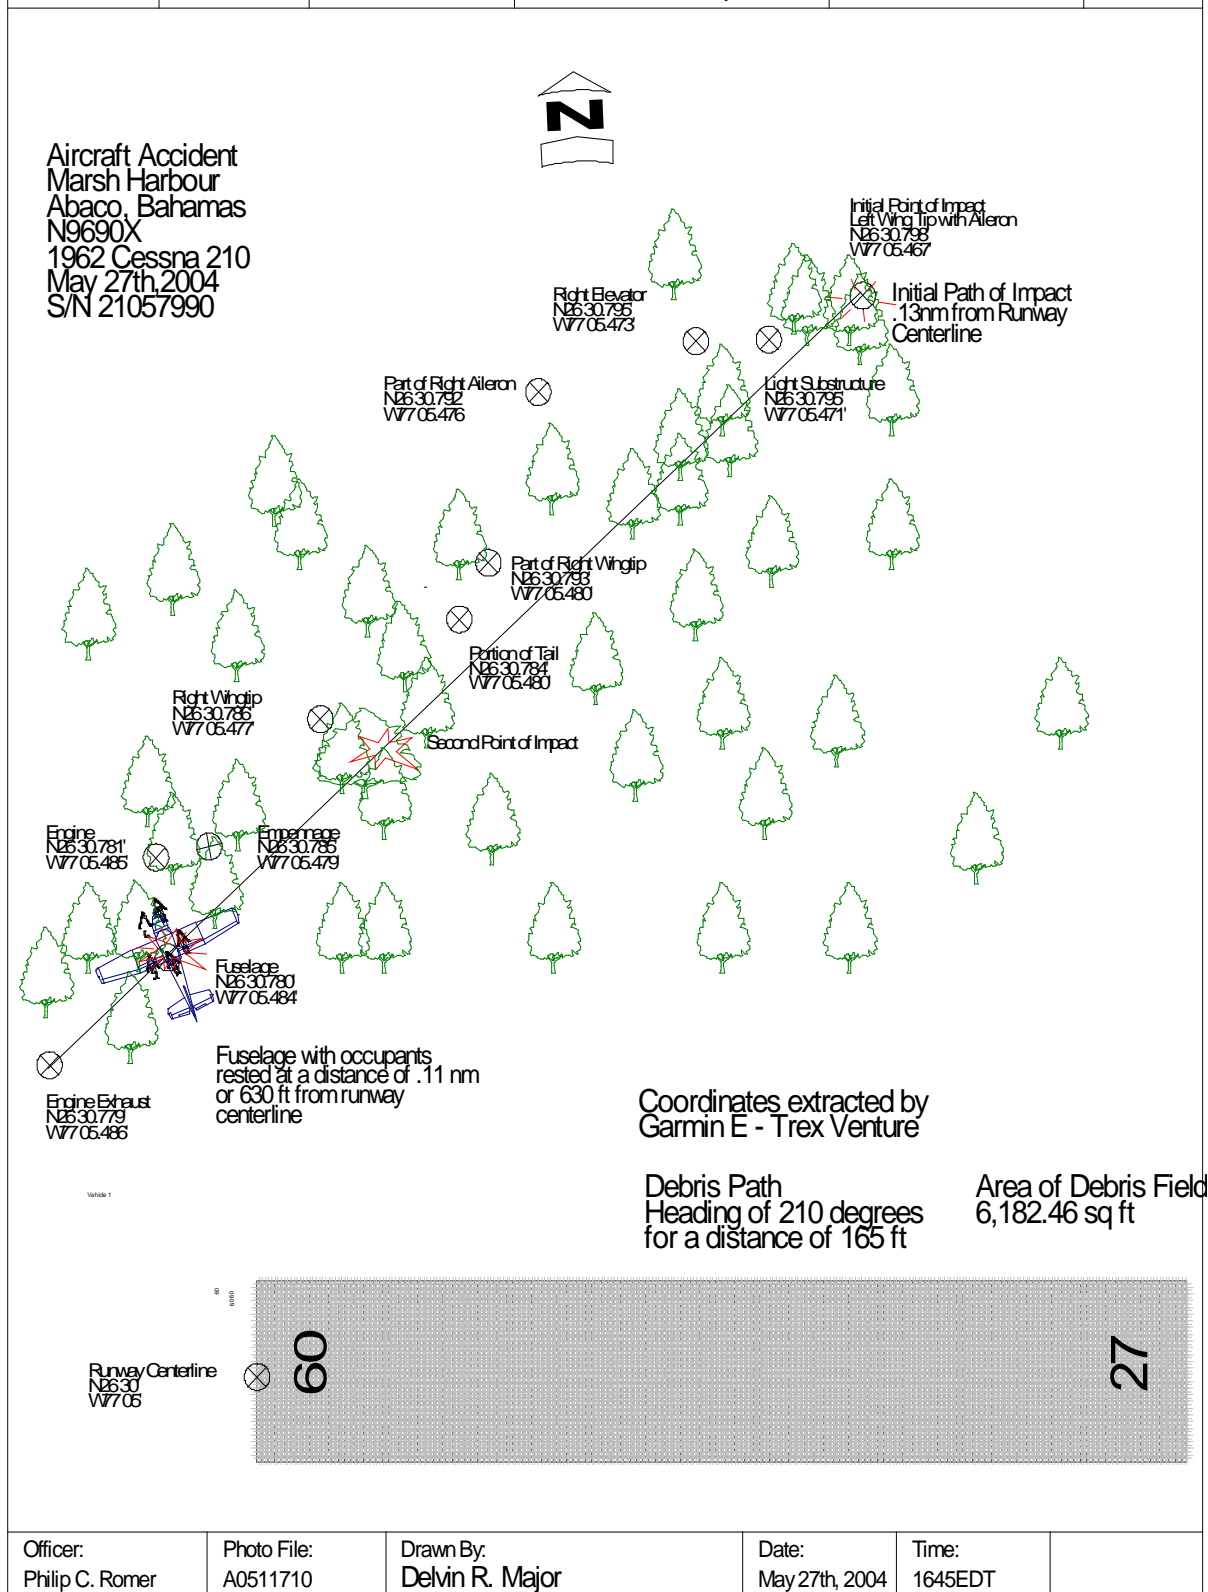
Case Name: Accident	Case No.: A0411710	Description: Off Aircraft	Address1: Marsh Harbour Airport	Address2: Marsh Harbour Bahamas	County: Bahamas
------------------------	-----------------------	------------------------------	------------------------------------	------------------------------------	--------------------

Officer: Philip C. Romer	Photo File: A0511710	Drawn By: Delvin R. Major	Date: May 27th, 2004	Time: 1645EDT	
-----------------------------	-------------------------	------------------------------	-------------------------	------------------	--

The aircraft left wing made initial contact with trees, while in a left spiral in an attempt to lose altitude. Multiple tree strikes occurred beginning about 165 feet from initial impact up to making contact with the ground. Tree heights in the area were estimated at 40 feet. The initial tree strike occurred at coordinates N26 30.798 latitude and, W77 05.467 longitude and .13 nautical miles from threshold centerline of runway 09. The left wingtip with left aileron attached was found at this location.

Tree strike heights decreased from the initial point toward the location of the main wreckage over a distance of 165 feet prior to ground impact. The angle formed by the tree strikes relative to the terrain was approximately 45 degrees. A light assembly substructure and part of the aircraft was found 34 feet from the initial point of impact and 8 feet to the right of the centerline field of debris at position N26 30.795' latitude and W 77 05.471' longitude.

The right wing separated from the aircraft near the fuselage and wing attachment point. A subsequent impact was made with a pine tree at GPS position N26 30.786' W77 05.477. No aircraft components were found at this location. Part of the right wingtip was located at GPS position N26 30.790' latitude and W77 05.480 longitude, 80 feet from the initial point of impact and 37 feet right of the centerline field of debris.

The right wing was located 133 feet from the initial impact, 12 feet right of the centerline field of debris, and was found inverted. The flap and aileron were found attached. The aileron hinges had failed at several of the wing attachment points. The wing strut remained attached to the fuselage. Part of the remaining wing tip was bent upward, relative to the root, at a point about mid-span. At this mid-span location, the leading edge was crushed and the upper skin was torn. An additional impact mark was located near the root, with a crease running aft along the upper skin. Based on the reading off the fuel totalizer less than 5 gallons of fuel remained in the tanks over Treasure Cay, some 26 miles from Marsh Harbour Abaco. Some fuel however was found in the right wing tank its amount undetermined.

The aircraft came to rest on its right side with the left wing draped over top of the fuselage. It was inverted. Part of the flap was attached. The wing was bent downward along the entire span, relative to the root. The tip and part of the aileron was missing. The wing strut was secured to the wing fitting and part of the flap remained attached. It exhibited some deformation but otherwise appeared intact. There was no fuel found in the left tank.
